Example riparian wetland feature and naturalized corridor, upper Fletcher's Creek, Brampton, Ontario.

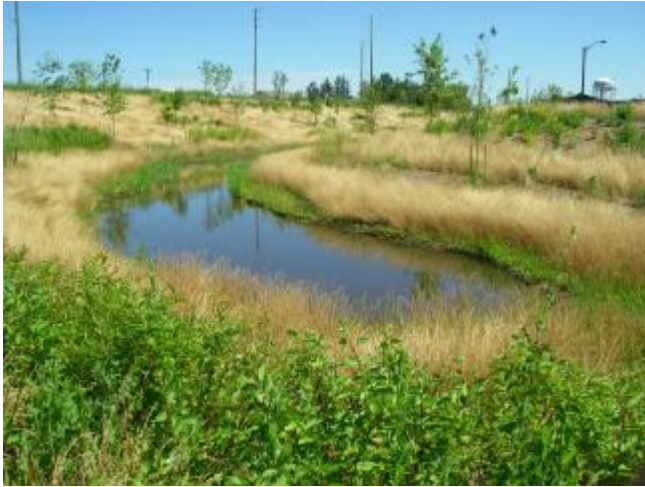
Photo showing 90 degree bend in created channel

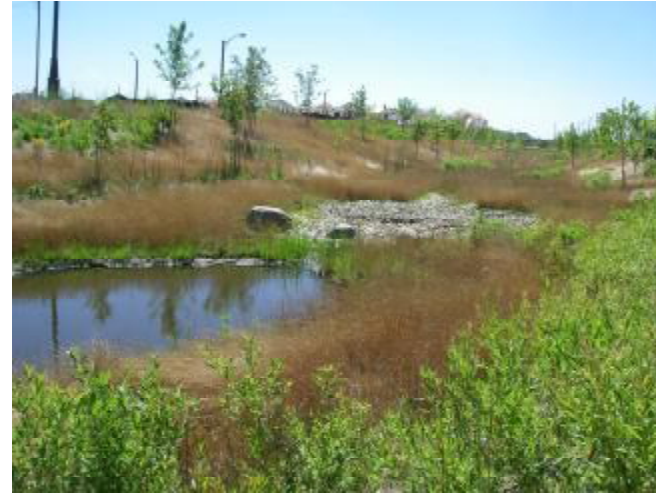
Photo showing dry riffle and wetland morphology

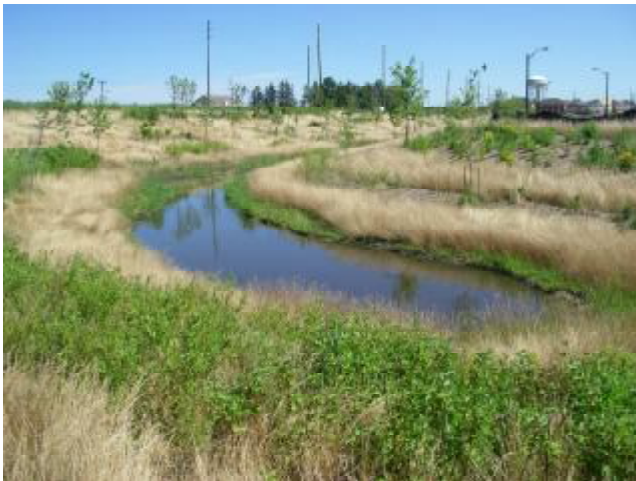
Photo showing online wetland feature at channel bend

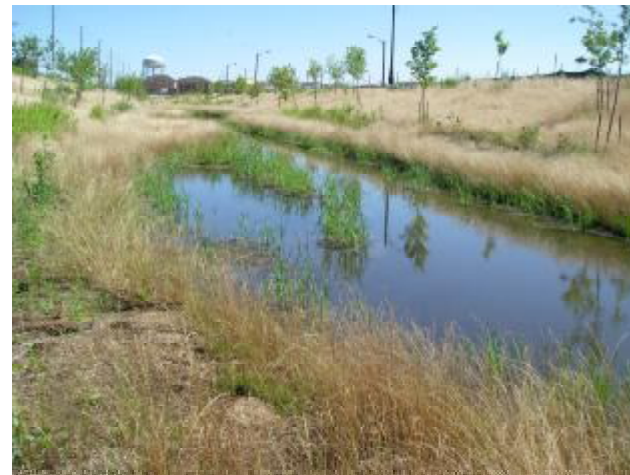
Photo showing varying depths of wetland features

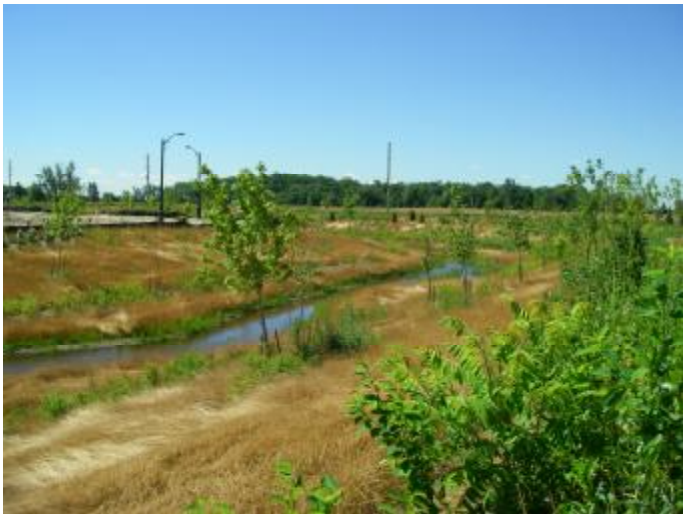
Photo showing linear wetland feature and naturalized corridor

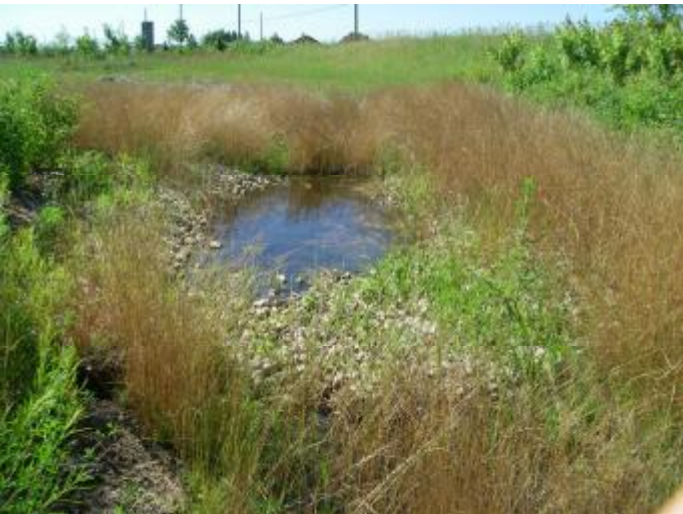
Photo showing offline wetland feature

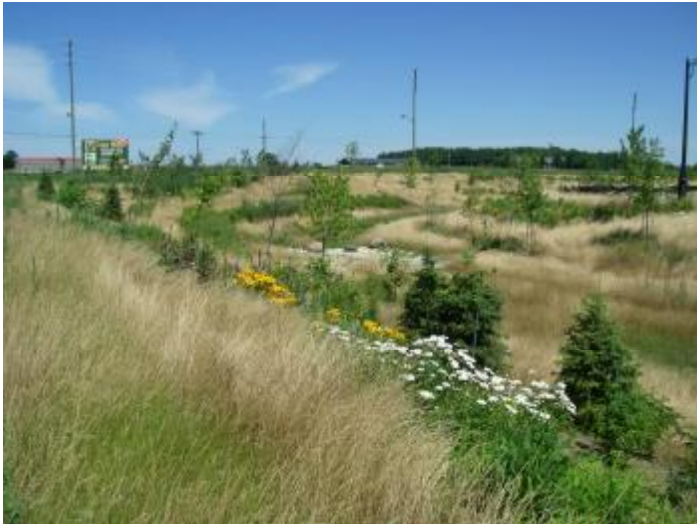
Photo showing naturalized corridor

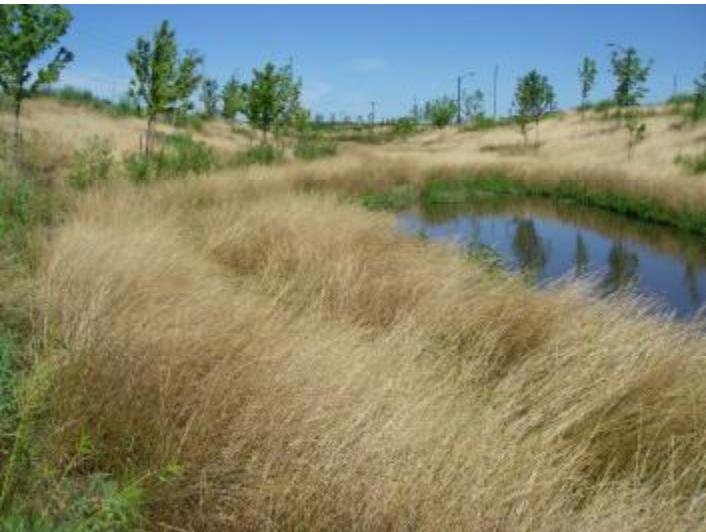
Photo showing offline wetland feature
